Manhole Inspection Summary

Manhole # S25Q1_007MH

Insp Date: **3/5/08 10:04 AM**

Location Address: **3221 Magnolia Ave.**

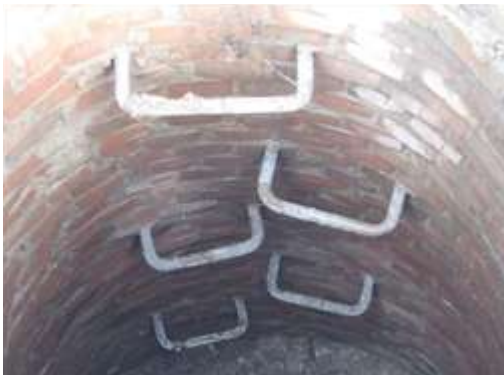
Steps Count: **5** Missing: **0** ☐ Corroded

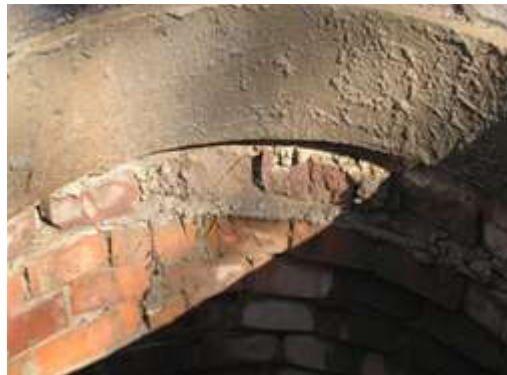
Defect 1

Infiltration: ☐ None ☐ Joint ☐ Cracks ☒ Mortar ☐ Roots ☐ Wall

Infiltration

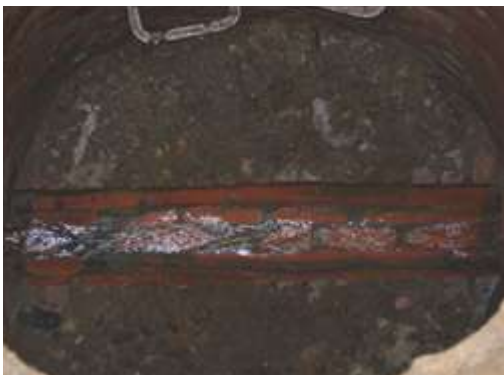
Defect 2

Condition: ☒ Sound ☐ Cracked ☐ Root Intrusion ☐ Deteriorated ☐ Leaks ☐ Debris

Bench

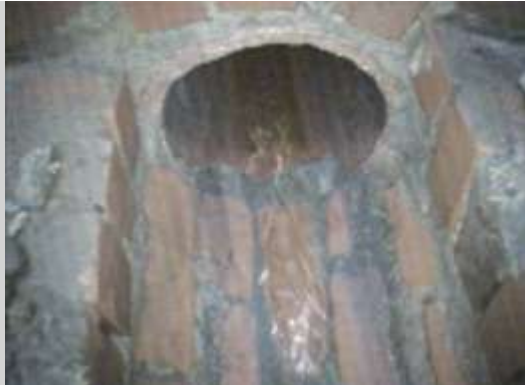
12 O'Clock Outflow

8 in. Circular Gravity Sewer
Pipe Out @ 12 O'Clock

Pipe Height: **9.6** (in.) Rod and Bar (Angled)
Pipe Material: **Clay** ☐ Pipe Lined
Invert Depth: **10.62** (ft.) Flow Characteristics: **Fast**
Deposits: ☒ None ☐ Mud ☐ Sludge ☐ Debris ☐ Grease
Silt Depth: (in.) Deposits Extent:
Infiltration: **None** Pipe Seal Cond: **Sound**

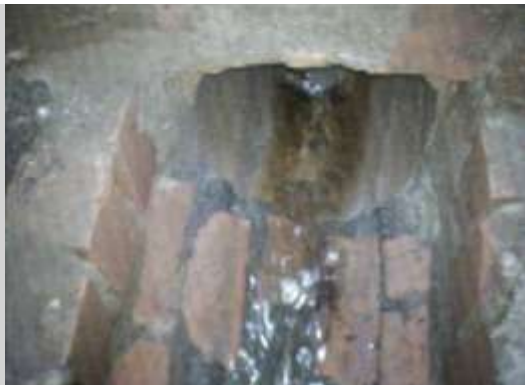
6 O'Clock Inflow

8 in. Circular Gravity Sewer
Pipe In @ 6 O'Clock

Pipe Height: **9.6** (in.) Rod and Bar (Angled)
Pipe Material: **Clay** ☐ Pipe Lined
Invert Depth: **10.37** (ft.) Flow Characteristics: **Fast**
Deposits: ☒ None ☐ Mud ☐ Sludge ☐ Debris ☐ Grease
Silt Depth: (in.) Deposits Extent:
Infiltration: **None** Pipe Seal Cond: **Sound**
